# BELZONA LEVELS AND PROTECTS ERODED CONCRETE

ID: 1185

## PROBLEM

Acids and caustic mixture had eroded the concrete and EPA made the client repair the concrete so Mercury would not accumulate on the floor.

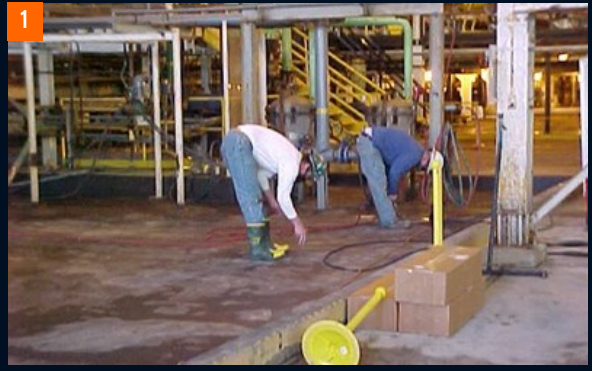
Chemicals had attacked the concrete

1. Overall view of the containment area
2. Using slurry mix of Belzona 4111 to level low areas
3. First coat of Belzona 5811 with non-slip aggregate
4. Final coat of Belzona 5811
