# BELZONA ALTERNATIVE TO HARD FACE WELDING

ID: 1186

A 40 ft screw conveyor handling bark and ash.

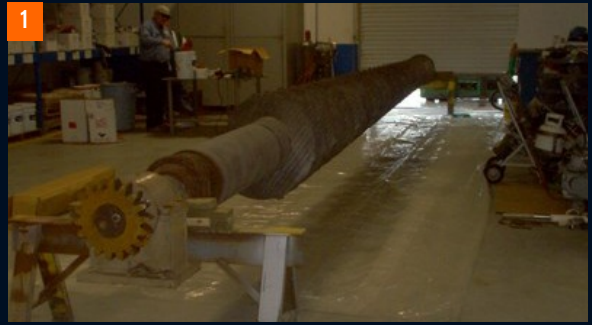
1. Overall view of the 40 ft screw conveyor
2. Screw conveyor with Belzona 1812 applied
3. Close up of the Belzona lining
4. After 5 years, 75% still OK and was repaired in place

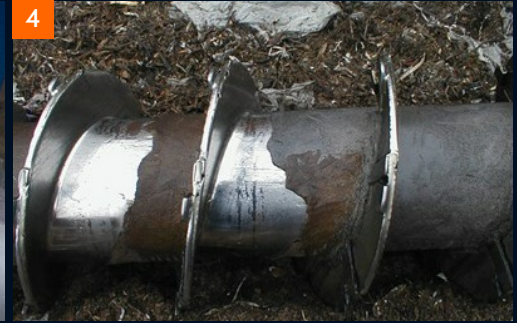
Belzona lasted for over 5 years where the hard facing lasted about the same but was twice the price. Belzona® 1812 can be repaired in place but not hard face welding.
