# BELZONA SEALS CHEMICAL BUNKERS FROM THE ENVIRONMENT

ID: 1187

Underground fertilizer storage bunker

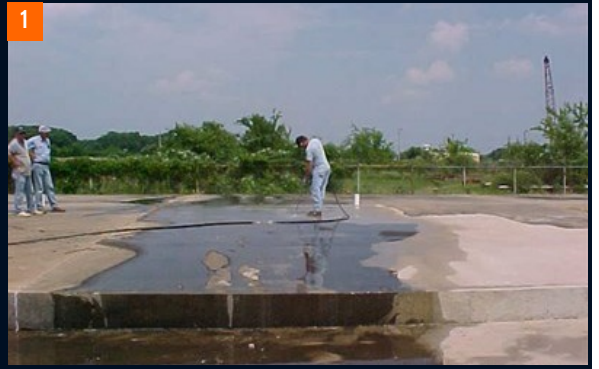
1. Cleaning the concrete
2. Overall view of cracks conditioned with Belzona 3911
3. Joints and cracks sealed with Belzona 3111
4. Spraying coat of clear cladding

Application was carried out in accordance with a modified Belzona Know-How System Leaflet RPA-1. Surface prepared by pressure washing then all cracks and joints sealed with Belzona® 3111 system. A coat of clear cladding was applied over the entire concrete storage area.

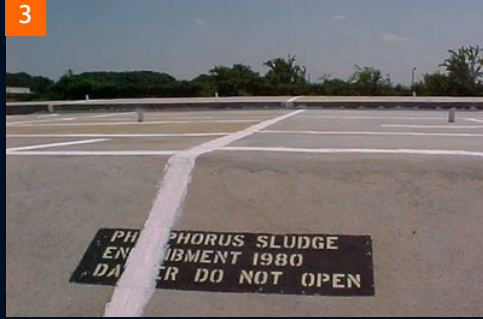
Water was penetrating into the expansion joints and cracks, reacting with old fertilizer which could cause further concrete failure and chemical release into the environment.
