# NASA GOES WITH BELZONA

ID: 1189

NASA, Alabama USA

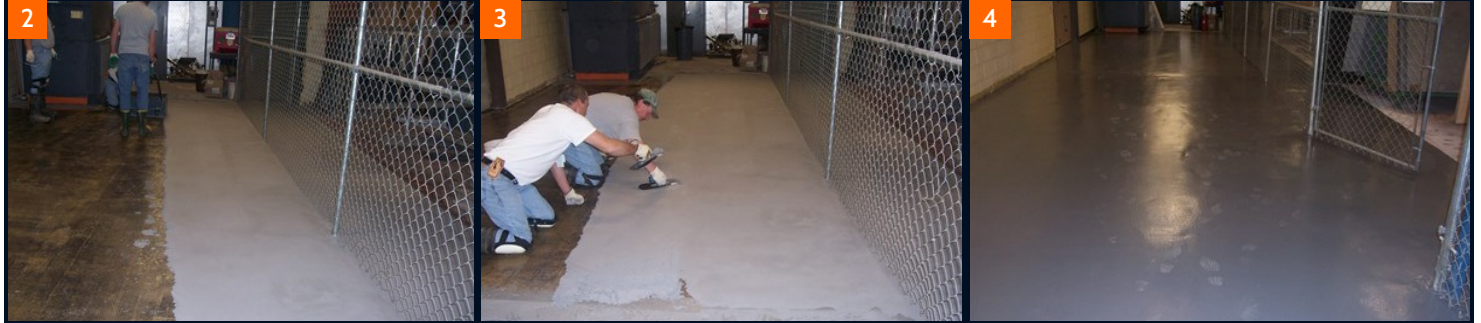
Old coating and repair materials were spalling and causing uneven areas of the floor. Fork trucks and equipment being moved across it was being damaged.

1. Overall view of the floor after preparation by Blastrack
2. Screed box laying out the Belzona 4131
3. Smoothing out the Belzona 4131
4. Final coats of Belzona 5231

Application was carried out in accordance with Belzona Know-How System Leaflet FPA-1. A screed box was used to apply 1/4 inch of Belzona® 4131. After the floor was leveled out Belzona® 5231 was applied in two coats.
