# NO FLOOR? NO PROBLEM FOR BELZONA

ID: 1190

Cooling Tower Floor was corroded away.

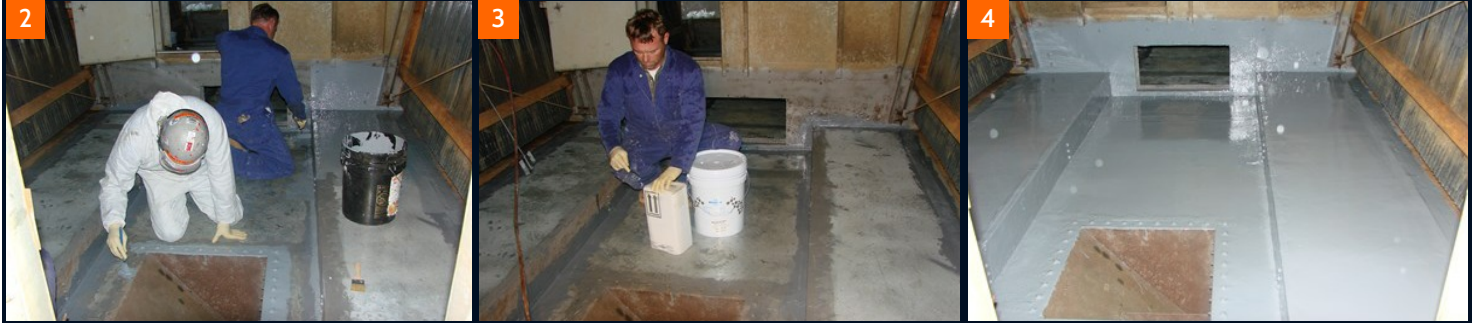
## PHOTOS

Floor was corroded badly and needed replacing during an outage.

1. Cooling tower protected from the weather
2. Sealing the seams with Belzona 3121
3. First coat of Belzona 5811 being applied
4. Completed application

Application was carried out in accordance with Belzona Know-How System Leaflets HEX-12 and GSS-3. The floor was abrasive blasted and new sheet metal cold plate bonded in place with Belzona® 1121. The seams were sealed with Belzona® 3121. Two coats of Belzona® 5811 were applied over the cold well surfaces.
