# BELZONA SEALS XYLENE CONTAINMENT AREA

ID: 1191

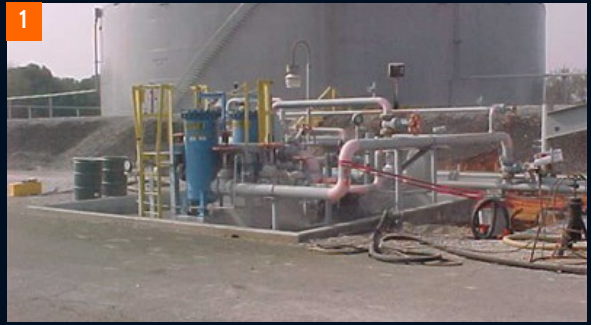
1. Overall view of the containment area
2. First coat of Belzona 5811 applied
3. Completed application

Application was carried out in accordance with Belzona Know-How System Leaflet TCC-15. Area abrasive blasted, damaged concrete repaired with Belzona® 4111 and Belzona® 5811 applied by spray.
