# 10 YEARS ON BELZONA 4131 KEEPS ON PROTECTING

ID: 1193

Neutralization Basin for a Power Plant was getting attacked by the acid/caustic mixture.

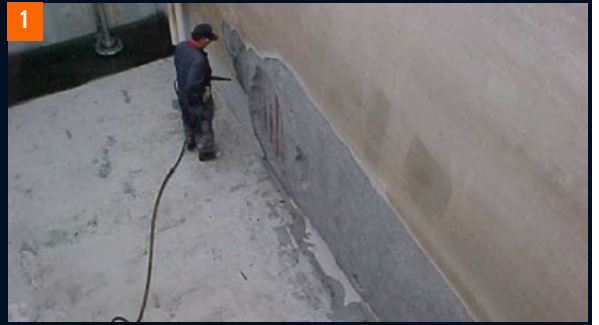
Chemicals had attacked the old lining and the concrete had deteriorated behind the fiberglass lining. Environmental contamination about to occur.

1. Overview of the deterioration exposed during surface preparation
2. One hole of 6 inches in depth
3. & 4 Applying Belzona 4131
