# BELZONA SAVES VALUABLE DOWNTIME IN FOOD FACTORY

ID: 1195

Barrel of chiller circulating salt water

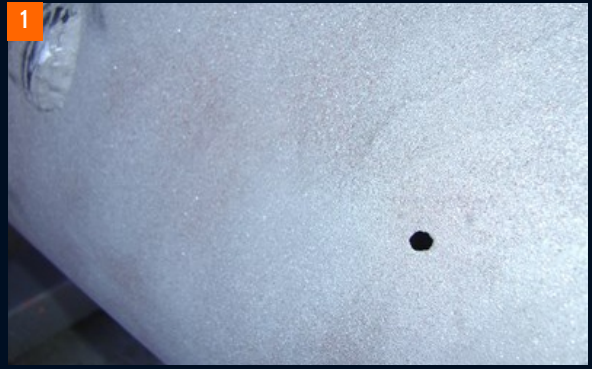
The carbon steel barrel began to leak due to erosion corrosion.

1. Abrasive grit blasting the surface showed hole in substrate
2. Contrast between optimal grit blast and grinding
3. Completed application
4. Review of the procedure by the application crew

The application was performed in accordance with Belzona Know-How System Leaflet VPF-11A.
