# BELZONA KEEPS AIRPORT SAFE FOR TRAVELLERS

ID: 1196

Expansion joints in passenger terminal.

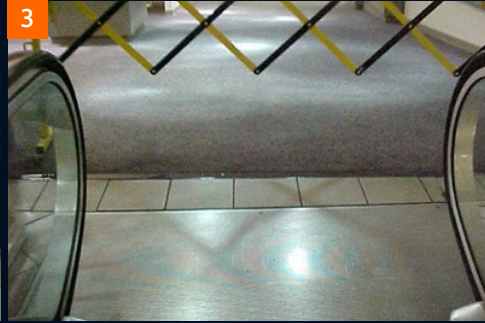
Old sealant was coming out of the joints. Steel plates over the joints did not alleviate the safety concerns.

1. The passenger terminal
2. One of the application areas
3. Problem joint in front of escalator
4. Completed Belzona 2221 application

Belzona 2221 (MP Fluid Elastomer)

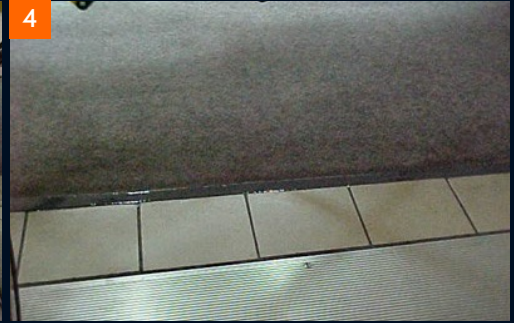
Joints still in service after 8 years. Excellent adhesion ensures no trip hazard created by failed sealant.

Application carried out in accordance with Belzona Know-How System Leaflet FPA-6.
