# BELZONA REPAIRS PARKING DECK EXPANSION JOINTS

Expansion joints in car park decks

International Airport, Alabama USA

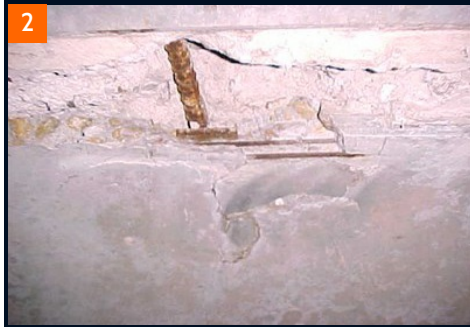
Sealant was failing and the concrete was deteriorated on each side of the joint on various levels of the parking deck. Fabricated expansion joints to be installed due to extreme movement.

1. View of expansion joint from the floor below
2. Spalled concrete due to water penetration and corrosion of rebar
3. Forming the Belzona 4111 using a 2" x 4" batten
4. Repair after the expansion joint was installed

Application was carried out in accordance with Belzona Know-How System Leaflet FPA-5. Joint nosings were rebuilt with Belzona® 4111 prior to bonding prefabricated expansion joints in with Belzona® 4911.
