# COMPETITOR FAILURE BRINGS BELZONA BACK

ID: 1198

## PROBLEM

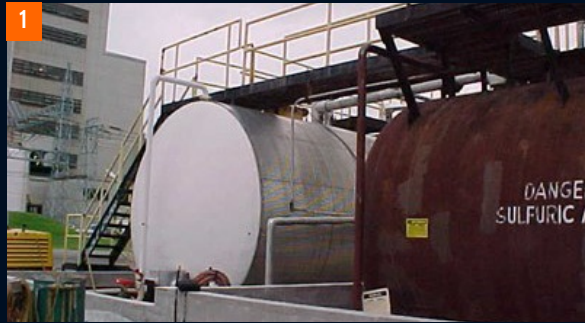
Sulfuric acid containment area. Failed coating allowed chemical leakage into the environment.

1. The acid and caustic containment area
2. Concrete damage
3. Coated containment area
4. Belzona 4311 on the acid tank after 12 years

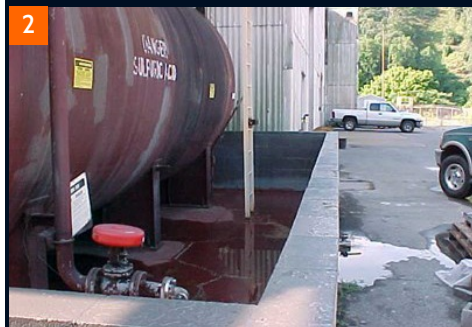
Competitor coating failed within two years. Belzona was asked to coat the concrete since Belzona® 4311 had been on the sulfuric acid tank itself for almost 12 years.

Application was carried out in accordance with Belzona Know-How System Leaflets TCC-9 and TCC-15. Damaged concrete was repaired with Belzona® 4111. Coated the acid side of the containment area with Belzona® 4311 and the caustic side with Belzona® 5811.

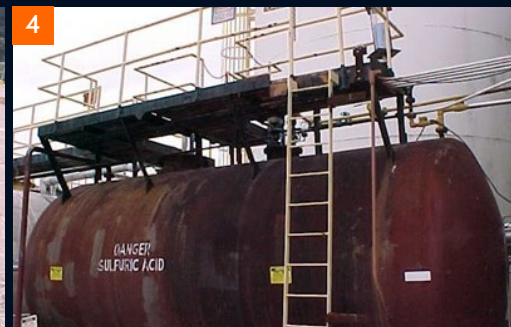
Belzona® 4311 was applied to the acid tank in 1988 and 12 years later was still perfect other than a little staining. The client had used a cheap coating in containment area first and after it failed decided to spend a little more money to make it last a long time. 8 years later and minor repairs are all that are needed on the Belzona.
