# BELZONA TACKLES PROBLEM WITH MUD FILTER

Faceplate of rotary valve on mud filter

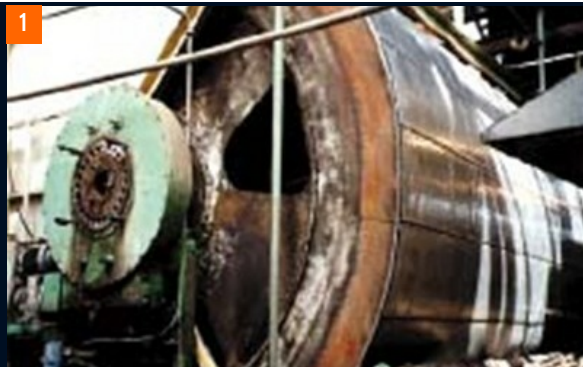
1. Mud filter.
2. Corroded faceplate of rotary valve.
3. Forming technique being used to apply Belzona Ceramic Metal System.
4. Completed application.

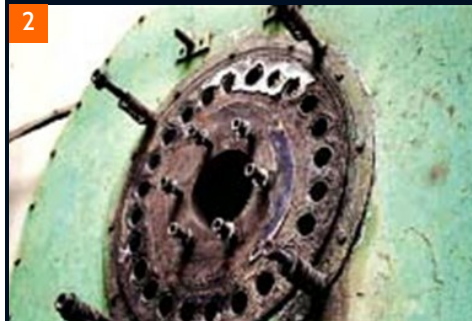
Corrosion on the faceplate of the rotary valve.
