# BELZONA SOLVES PROBLEM WITH AGITATOR BLADES

ID: 120

Agitator in settling tank of wastewater treatment station in a sugar beet mill

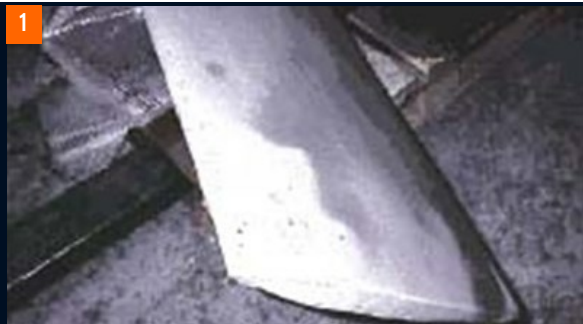
Abrasive solids in settling tank caused erosion on the surface of the agitator blades.

1. Damaged base of agitator.
2. Blades rebuilt with Belzona 1000 Series product.
3. Application of Belzona 2000 Series product.
