# BELZONA SEALS 20,000SQ.FT.CONTAINMENT AREA

ID: 1201

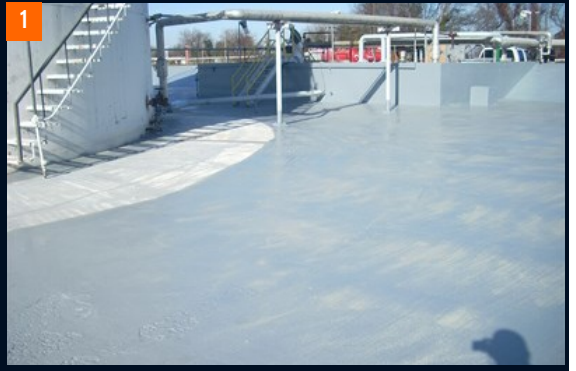
Cracks and failed coating over the concrete dyke.

1. Over view of the containment area
2. Close up of the expansion joints
3. 2nd coat of Belzona 5811 applied
4. Application completed with final coat of Belzona 5111

Application was carried out using a modified Belzona Know-How System Leaflet TCC-15. The concrete was high Pressure Water Jetted to remove loose coating and expansion joint sealant. Joints then sealed with Belzona® 4521. 2 coats of Belzona® 5811 and a top coat of Belzona® 5111 for UV Protection applied to entire area.
