# BELZONA ANCHORS THE TRACK

ID: 1202

Grout had failed around the blast furnace rails

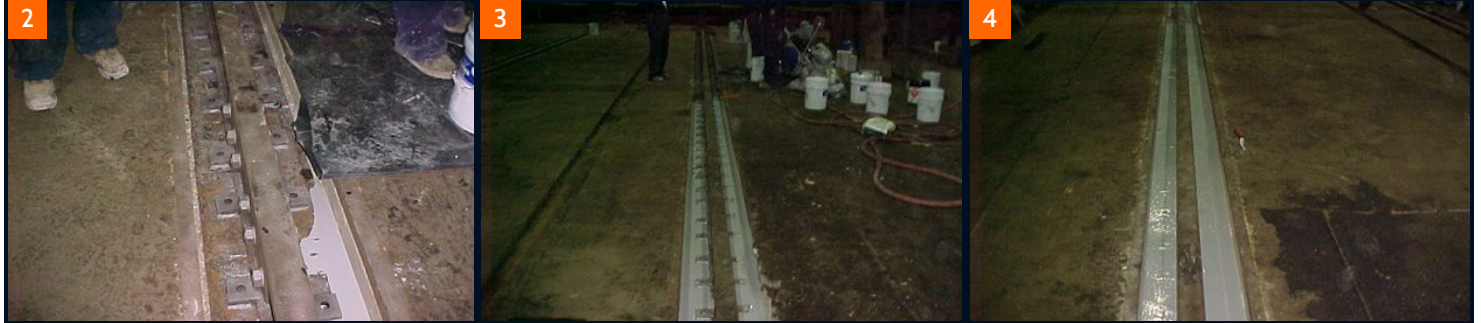
## PHOTOS

1. After surface preparation
2. Pouring the Belzona slurry
3. grouting almost complete
4. Completed project

Application was carried out in accordance with modified Belzona Know-How System Leaflet FPA-10. The old grout was removed and the rail was aligned and shimmed. A slurry mix of Belzona® 4111 was poured the length of the tract.
