# BELZONA BRIGHTENS UP HOSPITAL LAUNDRY FLOOR

ID: 1205

Hospital was looking to replace coating on laundry room floor.

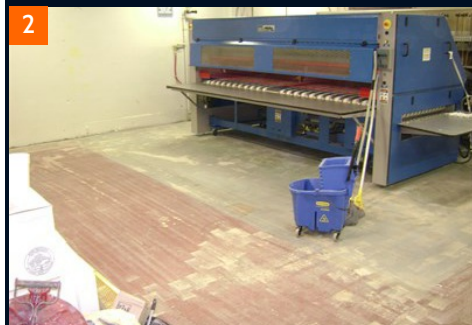
The coating that was currently on the floor was worn and causing slip hazards for the employees.

1. Floor prior to being prepared
2. Floor after being abraded
3. Belzona 5231 being applied
4. Completed floor
