# BELZONA PROTECTS CAUSTIC CONTAINMENT AREA

ID: 1206

Caustic Containment Area in water treatment plant.

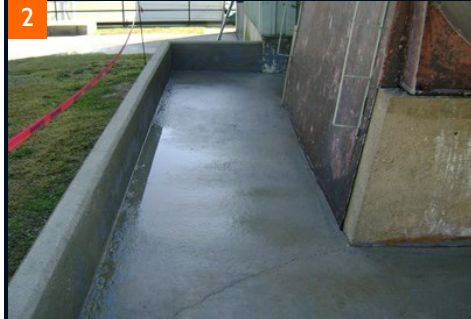
Customers Caustic Containment Area coating had failed and needed a new impervious coating installed.

1. Containment before old coating removed
2. Containment after old coating removed
3. & 4. Completed application

Application was carried out in accordance with Belzona Know-How System Leaflet TCC-15. Old coating was removed using high pressure water blasting. Belzona® 5811 was applied to both containment and tank stands.
