# BELZONA PROTECTS 98% SULFURIC ACID CONTAINMENT AREA

ID: 1207

## PROBLEM

Sulfuric Acid containment area coating had failed and needed re-coating.

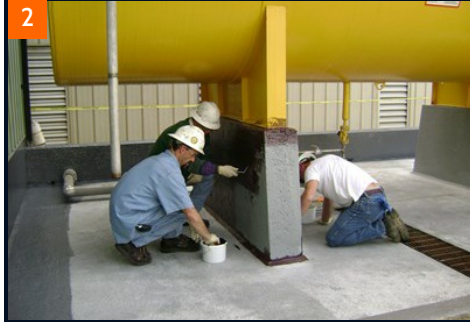
1. Old coating being removed
2. Belzona 4311 being applied
3. & 4. Completed application

Application was carried out in accordance with Belzona Know-How System Leaflet TCC-15. Old coating was removed using high pressure water blasting. Belzona® 4311 was applied to both containment and tank stands.
