# BELZONA EXTENDS LIFE OF COOLING TOWERS

ID: 1208

3 Marley cooling tower cold wells.

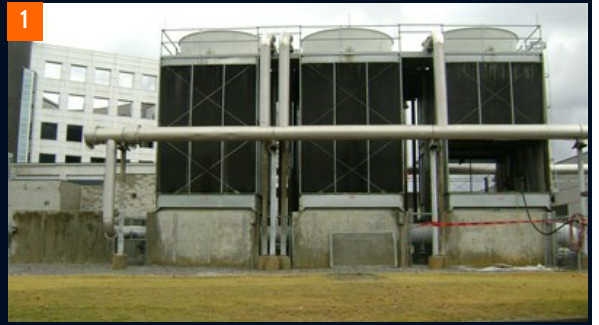
1. Marley Cooling Towers at the Bank
2. Belzona 3121 with Reinforcement Sheet being applied to seams
3. & 4. Completed application
