# BELZONA COATS CROSSOVER FLOOR

ID: 1209

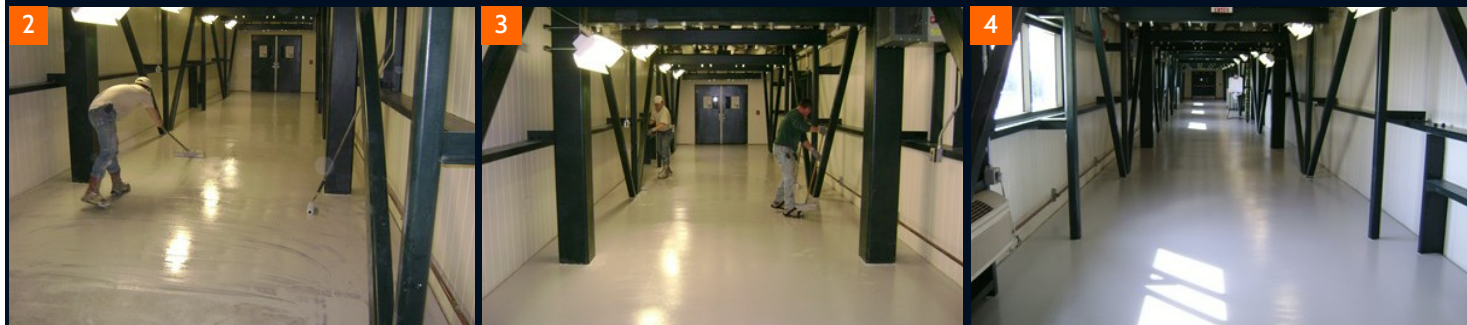
1. Removing the existing floor coating
2. Applying first coat of Belzona 5231
3. Applying second coat of Belzona 5231
4. Completed application

Application was carried out in accordance with Belzona Know-How System Leaflet FPA-3. Existing coating was removed using a walk behind floor grinder before applying the Belzona® 5231 system. applicators used spiked boots to aid access.
