# BELZONA SOLVES FAN PROBLEM IN SUGAR INDUSTRY

ID: 121

Exhaust boiler fan

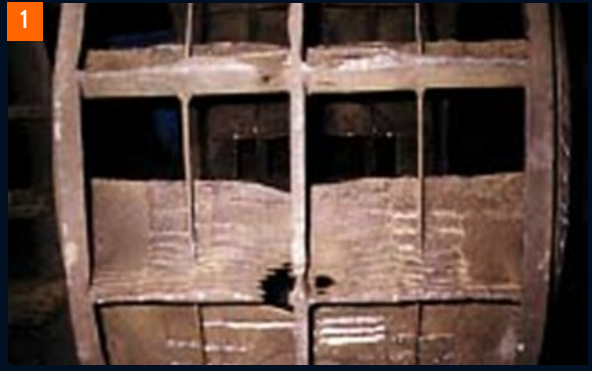
Exhaust boiler fan blades suffer from abrasion and wear due to fly ash

1. Extensive wear on fan blades.
2. Grit blasted surface.
3. Completed application.
