# UNIVERSITY STUDIES BELZONA FLOOR SOLUTION

ID: 1211

University, St Louis, Missouri U.S.A.

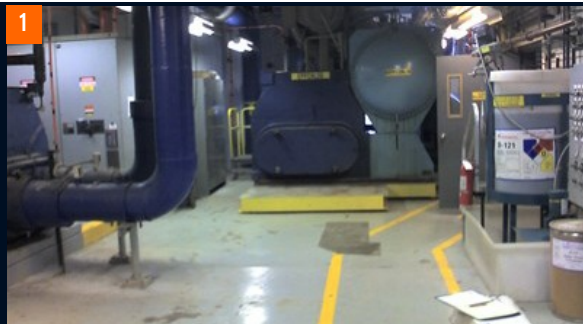
Floor caused trip hazards for employees and previous coatings required annual refurbishment.

1. Floor before repairs and coating
2. Close up of floor problems
3. Holes in floor repaired with Belzona 4111
4. Floor after coating with Belzona 5231
