# BELZONA PROTECTS CONCRETE IN DAIRY

ID: 1213

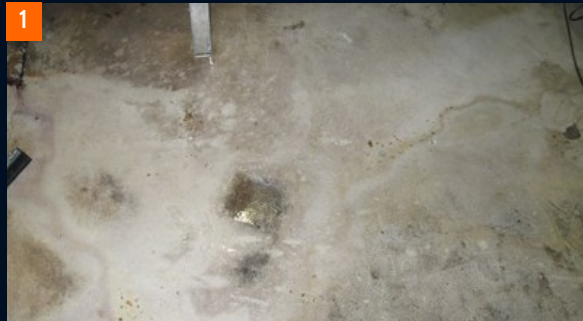
Customers concrete flooring was suffering from erosion due to chemical attack. Acidic cleaners are used in vessels and are drained onto the floors.

1. Original substrate
2. Completed coating around process vessel
3. Complete coating on opposite wall
4. Coating in front of door which endures heavy traffic
