# BELZONA SAVES MILLIONS IN DOWNTIME

ID: 1214

Water holding tank in the caustic/chlorine processing unit

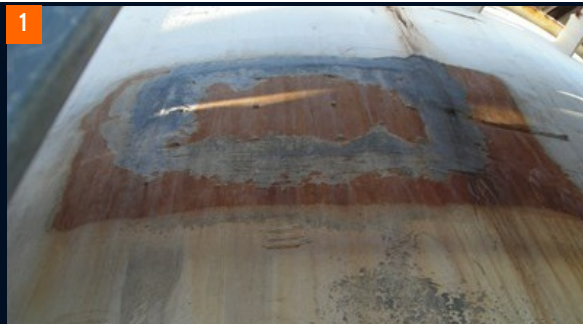
The vessel had been in service for over 20 years. It was suffering from severe corrosion and began to "rust through" in several places, causing the customer to become wary of complete failure.

1. View of tank from bottom to top
2. Steel patch bolted onto tank with layer of Belzona
3. Another view of the steel patch
4. View of additional steel patch at foot of the vessel

This vessel is a vital part of the plant and a complete failure would cause the entire unit to be shut down. The customer was producing \$5,000,000 in sales per week at that time and could not afford a failure. Belzona repair was completed in 1 day at a cost of around \$10,000, Belzona enabled the unit to stay in service until the January 2009 turnaround, when tank could be replaced.
