# BELZONA PROTECTS VERTICAL LIFT PUMP IMPELLER

ID: 1215

Open-faced vertical lift pump impeller

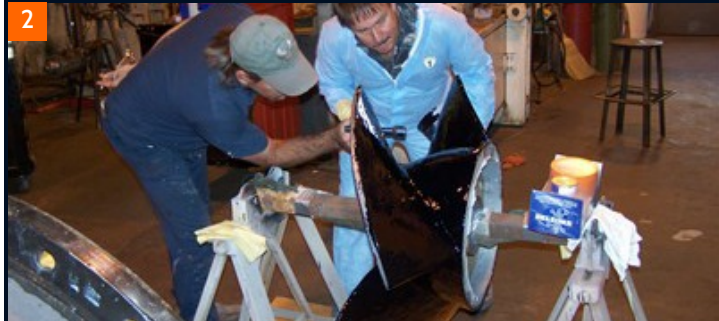
Due to the damage caused by the severe cavitation, costly rebuilding and rebalancing of the impeller was required on at least an annual basis.

1. Vertical lift impeller with Belzona 2941 conditioner applied
2. Inspection of impeller during coating process
3. Coating completed, awaiting installation

Application was carried out in accordance with Belzona Know-How System Leaflet CEP-3.

Belzona 2141 (ACR-Fluid Elastomer)
