# BELZONA PROTECTS WASTEWATER PUMP

ID: 1216

Wastewater pump in chemical company was experiencing severe corrosion from chemical attack.

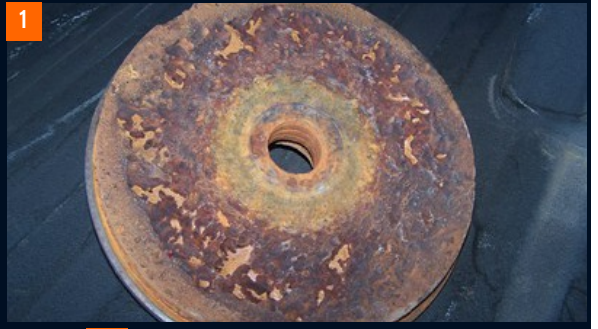
Strong chemicals within the wastewater process were attacking pump components which caused pitting and degradation of the carbon steel substrate resulting in loss of performance, loss of pump efficiency and frequent pump replacement.

1. Damaged wastewater pump head
2. Pump head rebuilt and coated
3. Damaged pump housing
4. Pump housing rebuilt and coated
