# BELZONA 4181 TAKES THE HEAT

ID: 1218

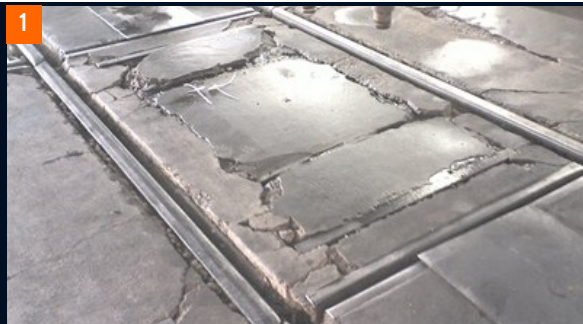
1. Overview of the rail car unloading station
2. Eroded concrete in the sump
3. Belzona 4181 being troweled onto the concrete surface

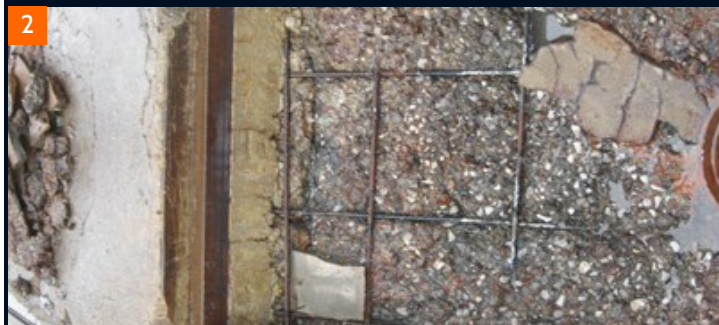
Concrete was eroding away due to steam and chemical wash downs.

Previous grouts and coatings had failed due to the steam and hot water. Belzona® 4181 provides outstanding resistance to the chemicals and heat in this environment.
