# BELZONA OVERCOMES WEAR PROBLEMS CAUSED BY CORN

ID: 1219

Corn Processing Plant, West Tennessee  
USA

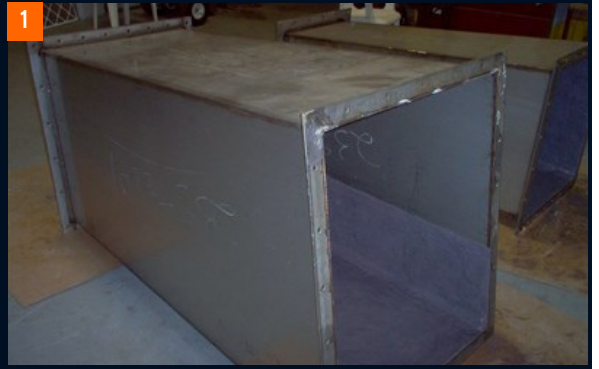
1. A Chute Lined with Belzona 1812
2. A Spout Lined with Belzona 1812
3. A Transition Piece Lined with Belzona 1812
4. Mixing Blades protected with Belzona 1812

Applications were carried out in accordance with Belzona Know-How System Leaflet SHM-13. After grit blasting the newly fabricated chutes, spouts, and mixing blades, 1/2 inch of Belzona® 1812 was applied to the wear areas.
