# BELZONA PROVIDES SOLUTION TO WATER INJECTION PUMP

ID: 122

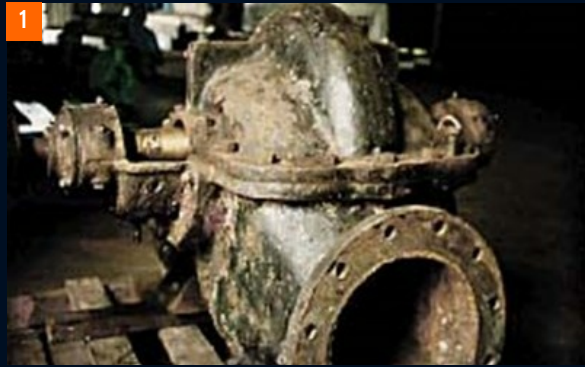
General erosion/corrosion on pump volute, wear ring seats and stuffing box

1. Split casing water injection pump.
2. Rebuilt wear ring seat and stuffing box.
3. Completely refurbished casing.

The application was carried out in accordance with Belzona Know-How Leaflets CEP-1, CEP-2 and CEP-3.

Belzona 1311 (Ceramic R- Metal)  
Belzona 1321 (Ceramic S-Metal)
