# BELZONA PROVIDES MORE GRIP AND REDUCES ACCIDENTS

ID: 1220

Corn Processing Plant, West Tennessee

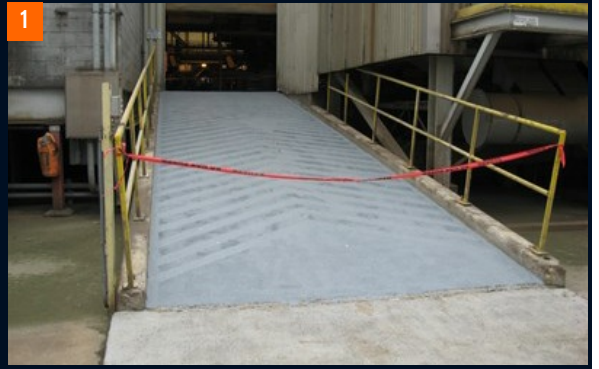
1. Ramp coated with Belzona 5811
2. Close look at the ramp
3. Completed application after application of Belzona 5111

Application was carried out in accordance with modified Belzona System Leaflet FPA-8. After abrasive blasting the concrete to roughen and remove the old coating, Belzona® 5811 was applied in chevron pattern and loaded to rejection with coarse grade of aggregate. The entire system was overcoated with Belzona® 5111 to provide UV protection.
