# TRANSFORMER LEAKS SEALED WITH BELZONA

ID: 1221

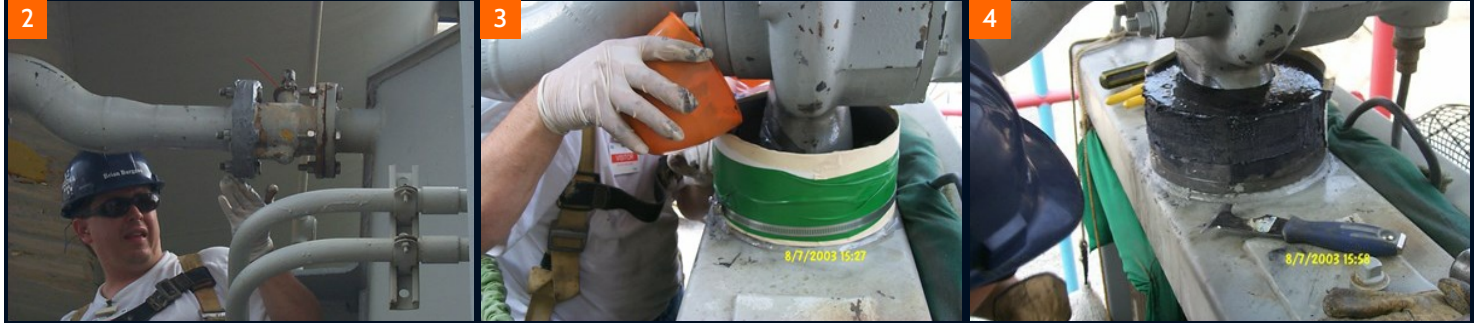
Transformers were leaking oil at the flanges.

1. Overview of the area
2. Stopping the leak with Belzona 1161
3. Pouring Belzona 2221 into the mold
4. Final view of cured Belzona

Application was carried out using a modified Belzona Know-How System Leaflet GSS-4. Leak was temporarily stopped with Belzona® 1161. Mold then created around the flanges and Belzona® 2221 poured into the mold to completely encapsulate the flange.
