# COOLING TOWER REFURBISHED WITH BELZONA

Cooling Tower with severe corrosion in cold water basins

Hospital, Memphis Tennessee USA

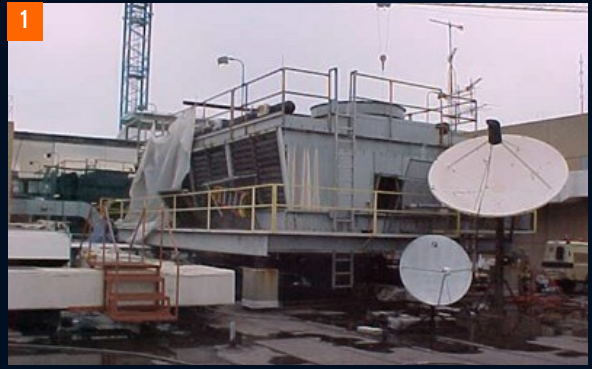
1. Cooling Tower overview
2. Blasting the Cold Water Basin
3. Belzona 3121 over the seams
4. Final coat of Belzona 5811
