# BELZONA SEALS CONCRETE COOLING TOWER BASINS

ID: 1224

Concrete Basins in cooling tower were leaking shortly after the start up of a new unit.

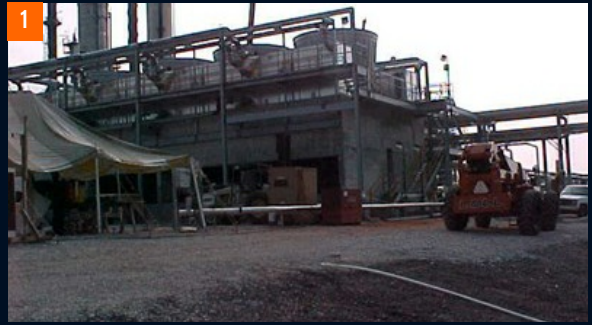
1. Cooling Tower overview
2. Walls repaired with Belzona 4111
3. First coat of Belzona 5811 being applied
4. Final Coat of Belzona 5811 applied

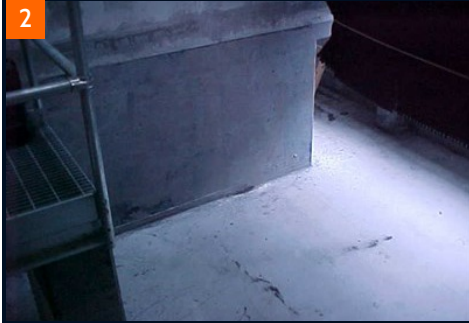
Cracks in the concrete were allowing water leaks into the environment.

Application was carried out in accordance with Belzona Know-How System Leaflets HEX-6 and -7. After grit blasting the concrete, cracks were sealed with Belzona® 4111 then coated with a reinforced Belzona® 5811 system. The entire basin was then coated with Belzona® 5811.
