# BELZONA PROTECTS NEW STEEL COVERS FROM HOT ACID SPILLS

ID: 1225

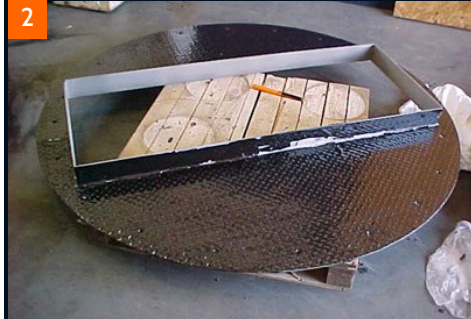
1. Newly fabricated steel plates
2. Belzona 4341 being applied
3. More items coated with Belzona 4341
4. Coating the concrete where plates are to be installed

Application was carried out in accordance with Belzona Know-How System Leaflet TCC-5 & 15. New plates were abrasive blasted and two coats of Belzona® 4341 applied. Concrete surrounds similarly prepared and protected.
