# BELZONA CREATES PERFECT FIT FOR CRUSHER BUSHING

ID: 1227

The Secondary Crusher.

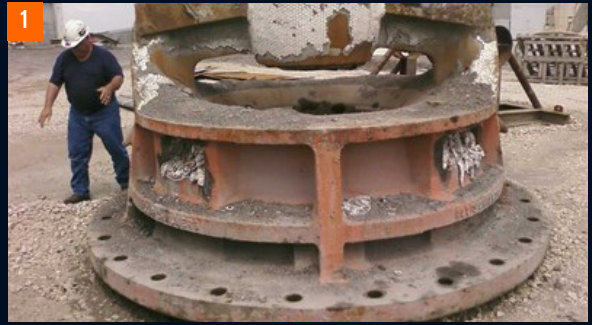
Upper Crusher Assembly (note size and weight) Damage to housing I.D and flange surface Release Agent being applied to new bushing New bushing lowered in place with jacking bolts used to position bushing

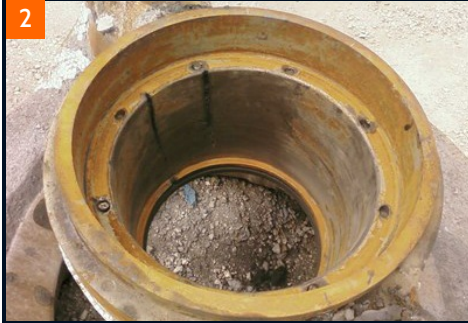
Upper Crusher Bushing seized on crusher shaft and spun inside the housing, resulting in loss of approximately .025" to the inner diameter. Housing suffered additional damage from cutting torch while removing old bushing.

Application was carried out in accordance with Belzona Know How System Leaflet MPT-7. Belzona® 1111 was used to fill grooves cut by welding torch and Belzona® 1321 to restore inner diameter tolerances using the new bushing re-form the housing.
