# BELZONA REFURBISHES RUBBER-LINED PUMP

ID: 123

Ash slurry pump

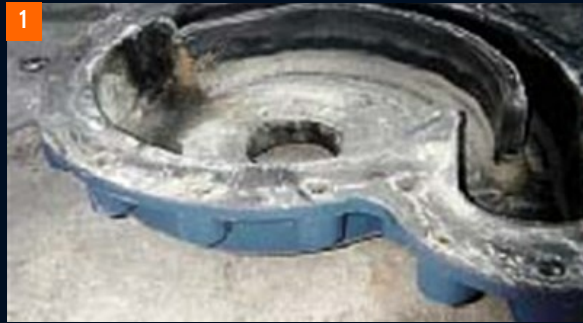
Pump casing and impeller suffer from erosion/corrosion due to the abrasive nature of the ash slurry.

1. View of uncoated casing.
2. Application of coating material to impeller.
3. Casing completely coated with Belzona 2000 Series product.
