# BELZONA REBUILDS LOADER PIN BUSH HOUSING

ID: 1230

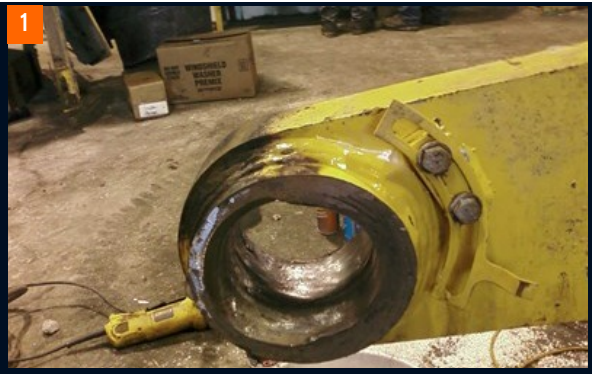
Wear in the pin bush housings. Conventional welding required the loader to be out of service too long.

1. Damaged pin bush housing
2. Surface preparation complete
3. Dummy shaft installed to maintain alignment
4. Finished and ready for service
