# BELZONA "DELIVERS" A SANITARY FLOORING SOLUTION

ID: 1232

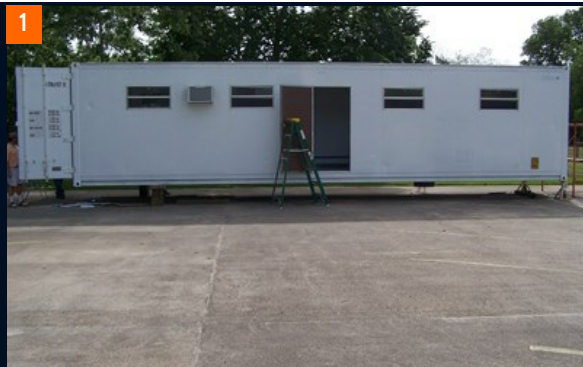
1. The portable birthing center
2. Floor prior to coating with walls taped off
3. Finished Belzona 5811 flooring application

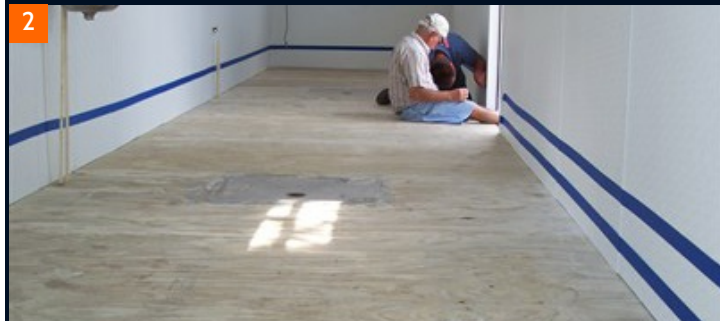
The raw plywood floor with no sealant would be difficult to maintain and keep clean in an area that required a very sanitary environment.

Application was carried out in accordance with Belzona Know-How System Leaflet FPA-3. The walls were taped off approximately 2 inches up the vertical edge, sanded, cleaned then coated with two coats of Belzona® 5811 with minimal Surefoot aggregate added during the first coat process.
