# BELZONA PROTECTS CONCRETE IN BIODIESEL PLANT

ID: 1234

Concrete surfaces around biodiesel pumps and tanks

Biodiesel Manufacturer, Memphis, TN

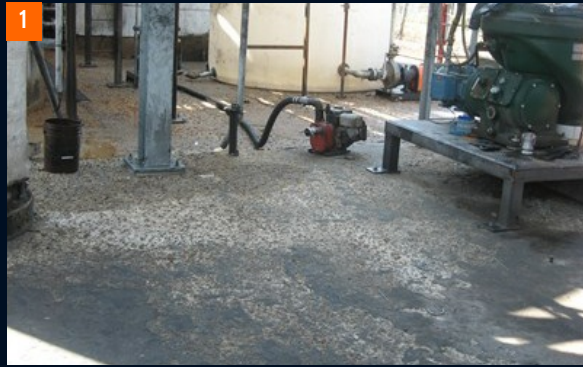
Biodiesel attacked the concrete substrate causing erosion leading to unsafe walking conditions.

1. Concrete pad before repair
2. Pad during repair
3. Completed project

Application was carried out in accordance with Belzona Know-How System Leaflet TCC-15. Surface was prepared with 20,000 psi pressure washer which removes deteriorated concrete and removes contamination at the same time. This repair was done over a 2 day period. Aggregate was applied into the Belzona® 5811 to create a non-slip walking surface.
