# BELZONA EMERGENCY SHAFT REPAIR AT PULP & PAPER FACILITY

ID: 1235

Shaft on the Primary paper machine.

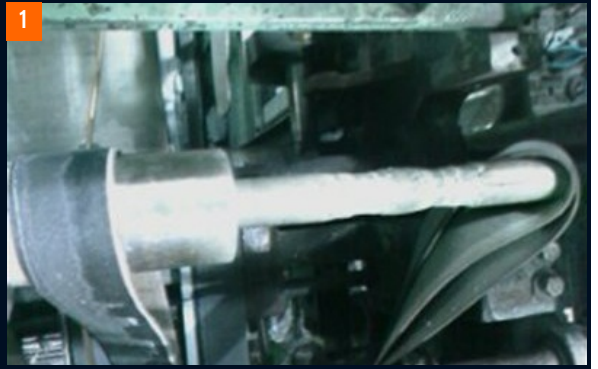
A bearing had run dry of lubrication and caused the entire line to shut-down.

1. Shaft prior to repair
2. Shaft during repair with former in place
3. Shaft after repair
