# BELZONA REPAIRS CORN WEAR

ID: 1237

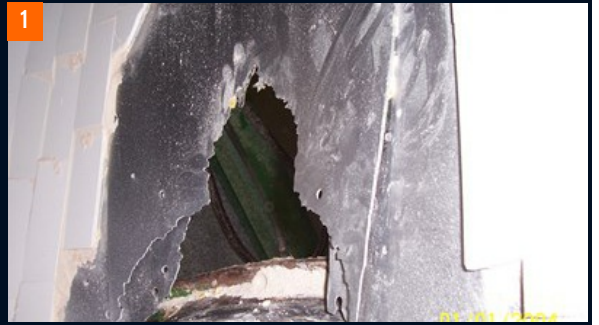
Ceramic tiles had fallen out of the vacuum system exposing the Stainless steel substrate. The corn being pulled through system quickly wore a hole through the steel causing loss of vacuum and stoppage of the unloading facility.

1. The hole in the Vacuum system prior to repair
2. External repair of hole with Belzna 1221 bonded plate
3. Internal repair with Belzona 1812 applied
