# BELZONA REPAIRS VACUUM PUMP ROTOR

ID: 124

Vacuum pump rotor

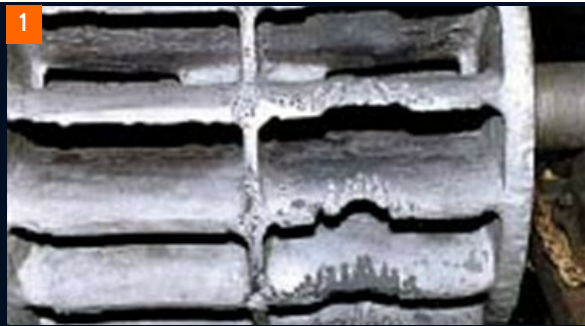
Cavitation damage was the principal problem on this rotor.

1. Extensive damage of vacuum pump easily visible.
2. Refurbished rotor.
3. Rotor after many years in service.

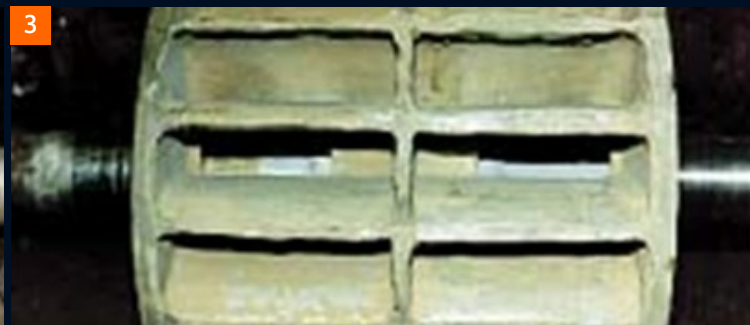
Belzona's repair system has proven resistant to cavitation. The repair has lasted over five years.
