# TANK BASE SEALING WITH BELZONA PRODUCT

ID: 1240

Oil storage tank.

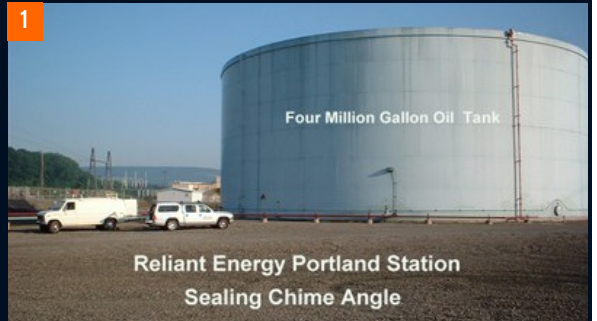
1. View of the tank
2. Chine angle before application
3. & 4. Finished application

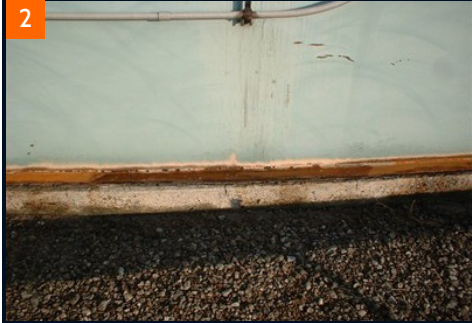
Corrosion at chine angle and water getting under the tank bottom
