# BELZONA REPAIRS OIL TANK LEAK

Leaking Oil Tank

Oil Refinery, Thailand

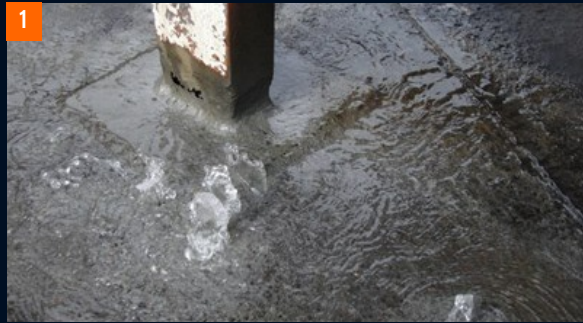
The roof deck of the tank had been subjected to severe corrosion leading to a local leak of the oil vapour. This was very hazardous to the plant operation and there was also a risk of rain water contamination into the tank.

1. Leaking oil tank
2. Prepared application area
3. Applying Belzona 1161
4. Applying Belzona 5831
