# BELZONA SEALS COOLING TOWER LEAKS

ID: 1245

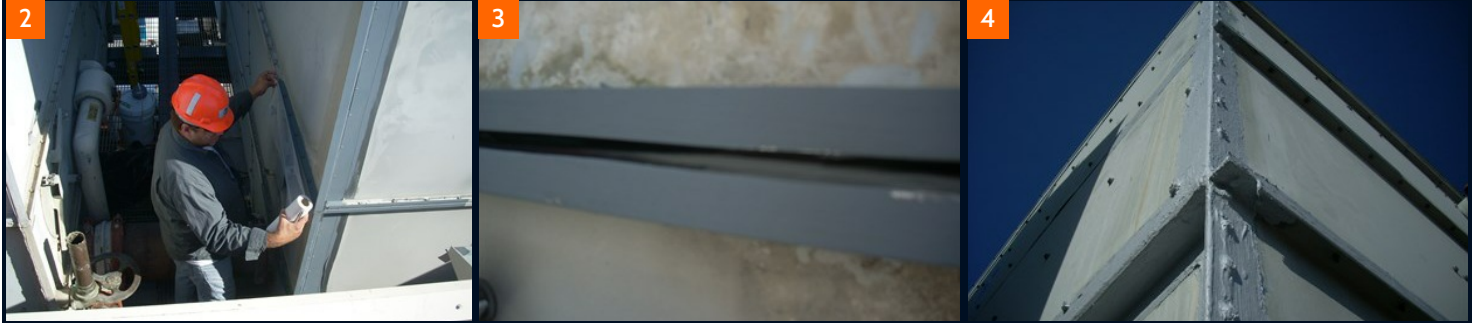
## PHOTOS

Cooling towers leaked from seams. The leaks froze the belt and motor drive in the winter.

1. Belzona 3921 applied to prepared area
2. Applying bond breaker tape
3. Applying Belzona 9311 (Reinforcing Sheet)
4. Application completed with Belzona 3111

Application was carried out in accordance with Belzona Know-How System Leaflet RPA-1. A fully reinforced Belzona® 3111 system was applied using Belzona® 3921 Conditioner.
