# STORAGE TANK ROOF REPAIRED USING BELZONA

ID: 1247

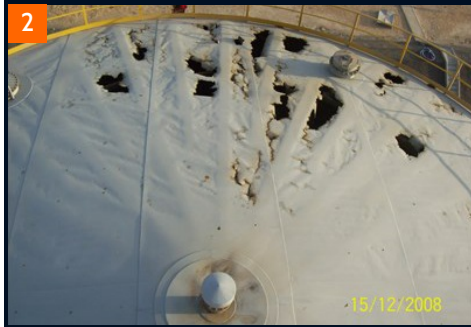
1. General view of the tank
2. The holes in the roof tank
3. Using two winches to carry the metal sheets & technicians
4. Application completed

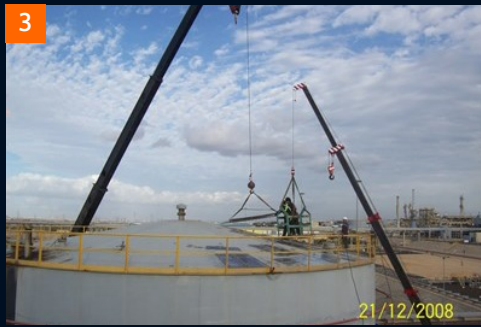
Several holes in the tank roof.

Application was carried out in accordance with Belzona Know-How System Leaflet TCC-1. Metal patches were formed to cover the holes and were bonded into place using Belzona Marine metal. The unsafe roof forced the applicators to use winches to support the plates and technicians on the tank to solve the problem.
