# BELZONA PROTECTS STAINLESS STEEL FROM ACID FUMES

ID: 1249

Tanks, dryers and pipes in fertilizer production plant

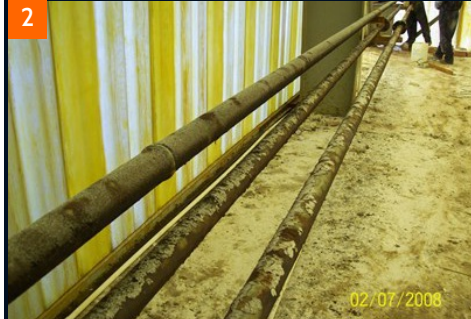
Stainless steel suffering corrosion and attack from HCl fumes generated in the production process.

1. General view to the factory
2. Corroded stainless steel pipes
3. Cleaning the surfaces
4. Application completed

Belzona® 5811 provided a cost effective solution to this problem, having good resistance to the fumes and being easily applied to the various surfaces.
