# BELZONA REPAIR AND PROTECTION OF DESALTER

ID: 1250

Desalter

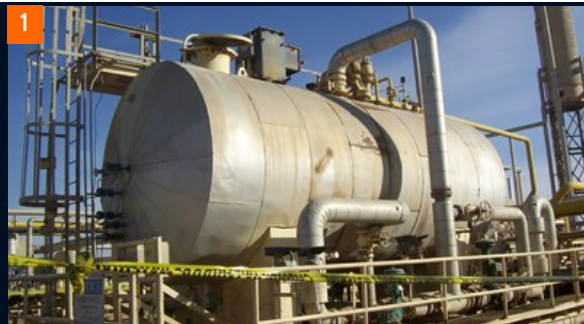
Several pitted areas in the lower half of the vessel needed to be rebuilt. Protection then required particularly for high salt levels in lower half of vessel.

1. General view of the Desalter
2. Rebuilding the pitting areas in the lower half
3. Finishing the coating of the upper half
4. Application completed
