# BELZONA REPAIR OF CONDENSATE TANK

ID: 1253

Leaking condensate return tank

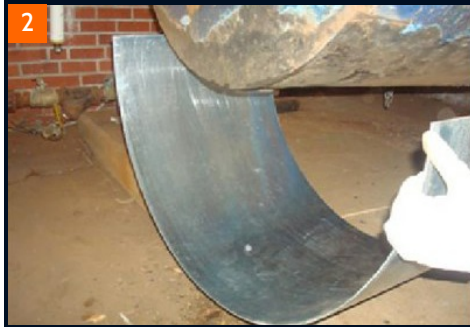
During summer maintenance of this facilities boiler plant, the condensate return tank was found to be severely corroded and leaking, with concern for its ability to make it through another heating season.

1. The leaking tank
2. Rolled plate
3. Plate bonded with Belzona 4181
4. Completed application

Application was carried out using a modified Belzona Know-How System Leaflet TCC-1. The tank was lifted for access and mechanically prepared with the MBX Bristle Blaster. A heavy gauge steel plate was fabricated and bonded into place with Belzona® 4181. Belzona® 1311 was then used to reinforce the tank ends.
