# BELZONA GETS GRIP ON CONVEYOR SLIPPAGE

ID: 1256

Conventional rubber lagged head pulley.

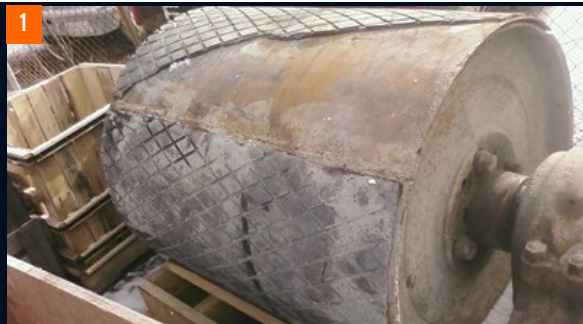
Pieces of rubber lagging were frequently torn loose due to build up. Excessive wear from moisture, chemical attack and abrasive media was causing belt to slip. Belt would often not track properly due to uneven lagging pads.

Head pulley with damaged rubber lagging  
Grit blasted pulley  
Belzona non-slip surface  
Completed and ready for service
